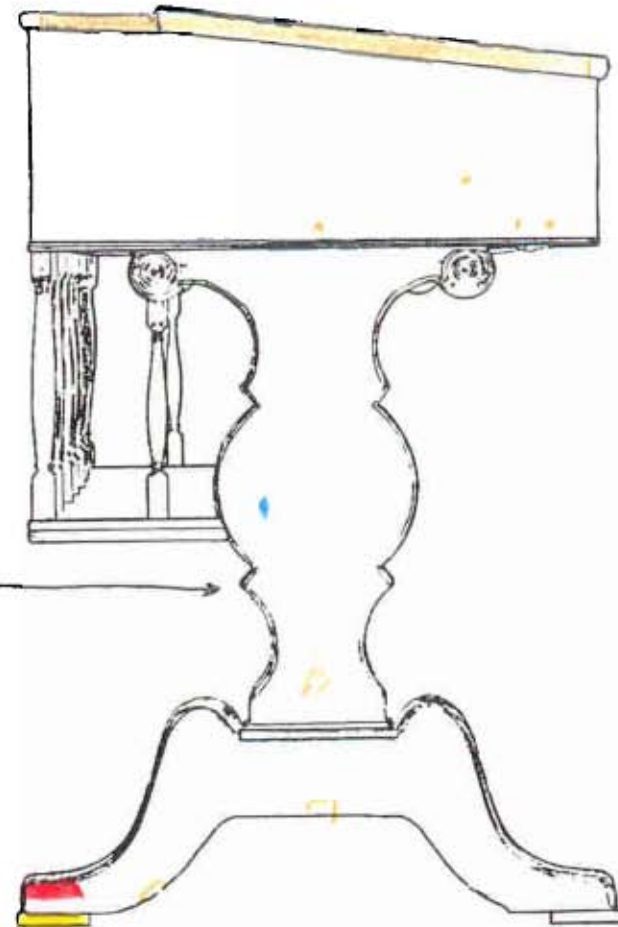
Left Side

*No cross-banded veneer*

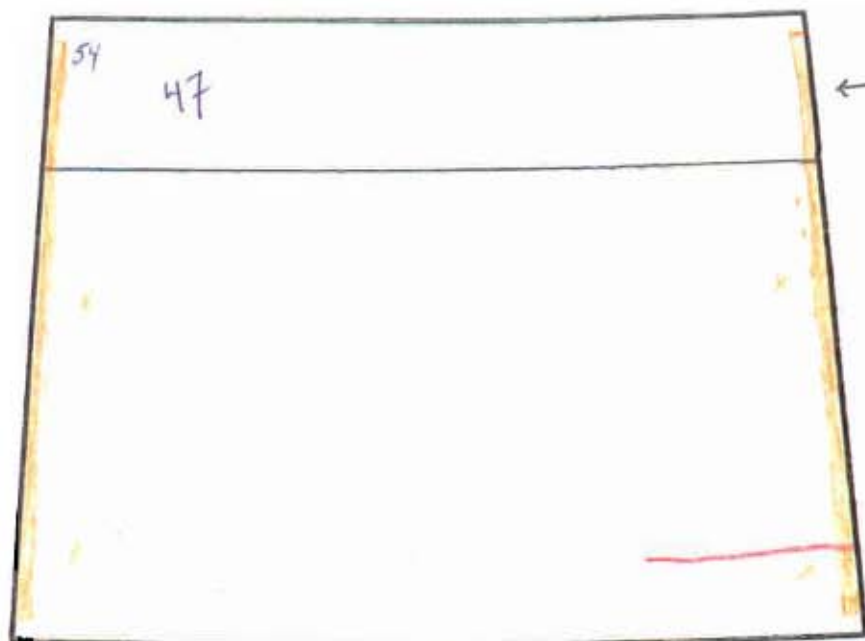
Top

← No inkwell opening
